Service Log AN/GRC-109 communication system  
PP2684/GRC109 rebuild  
26-Dec-2019, Virgil Cheng vr2xgm

Power section service history:

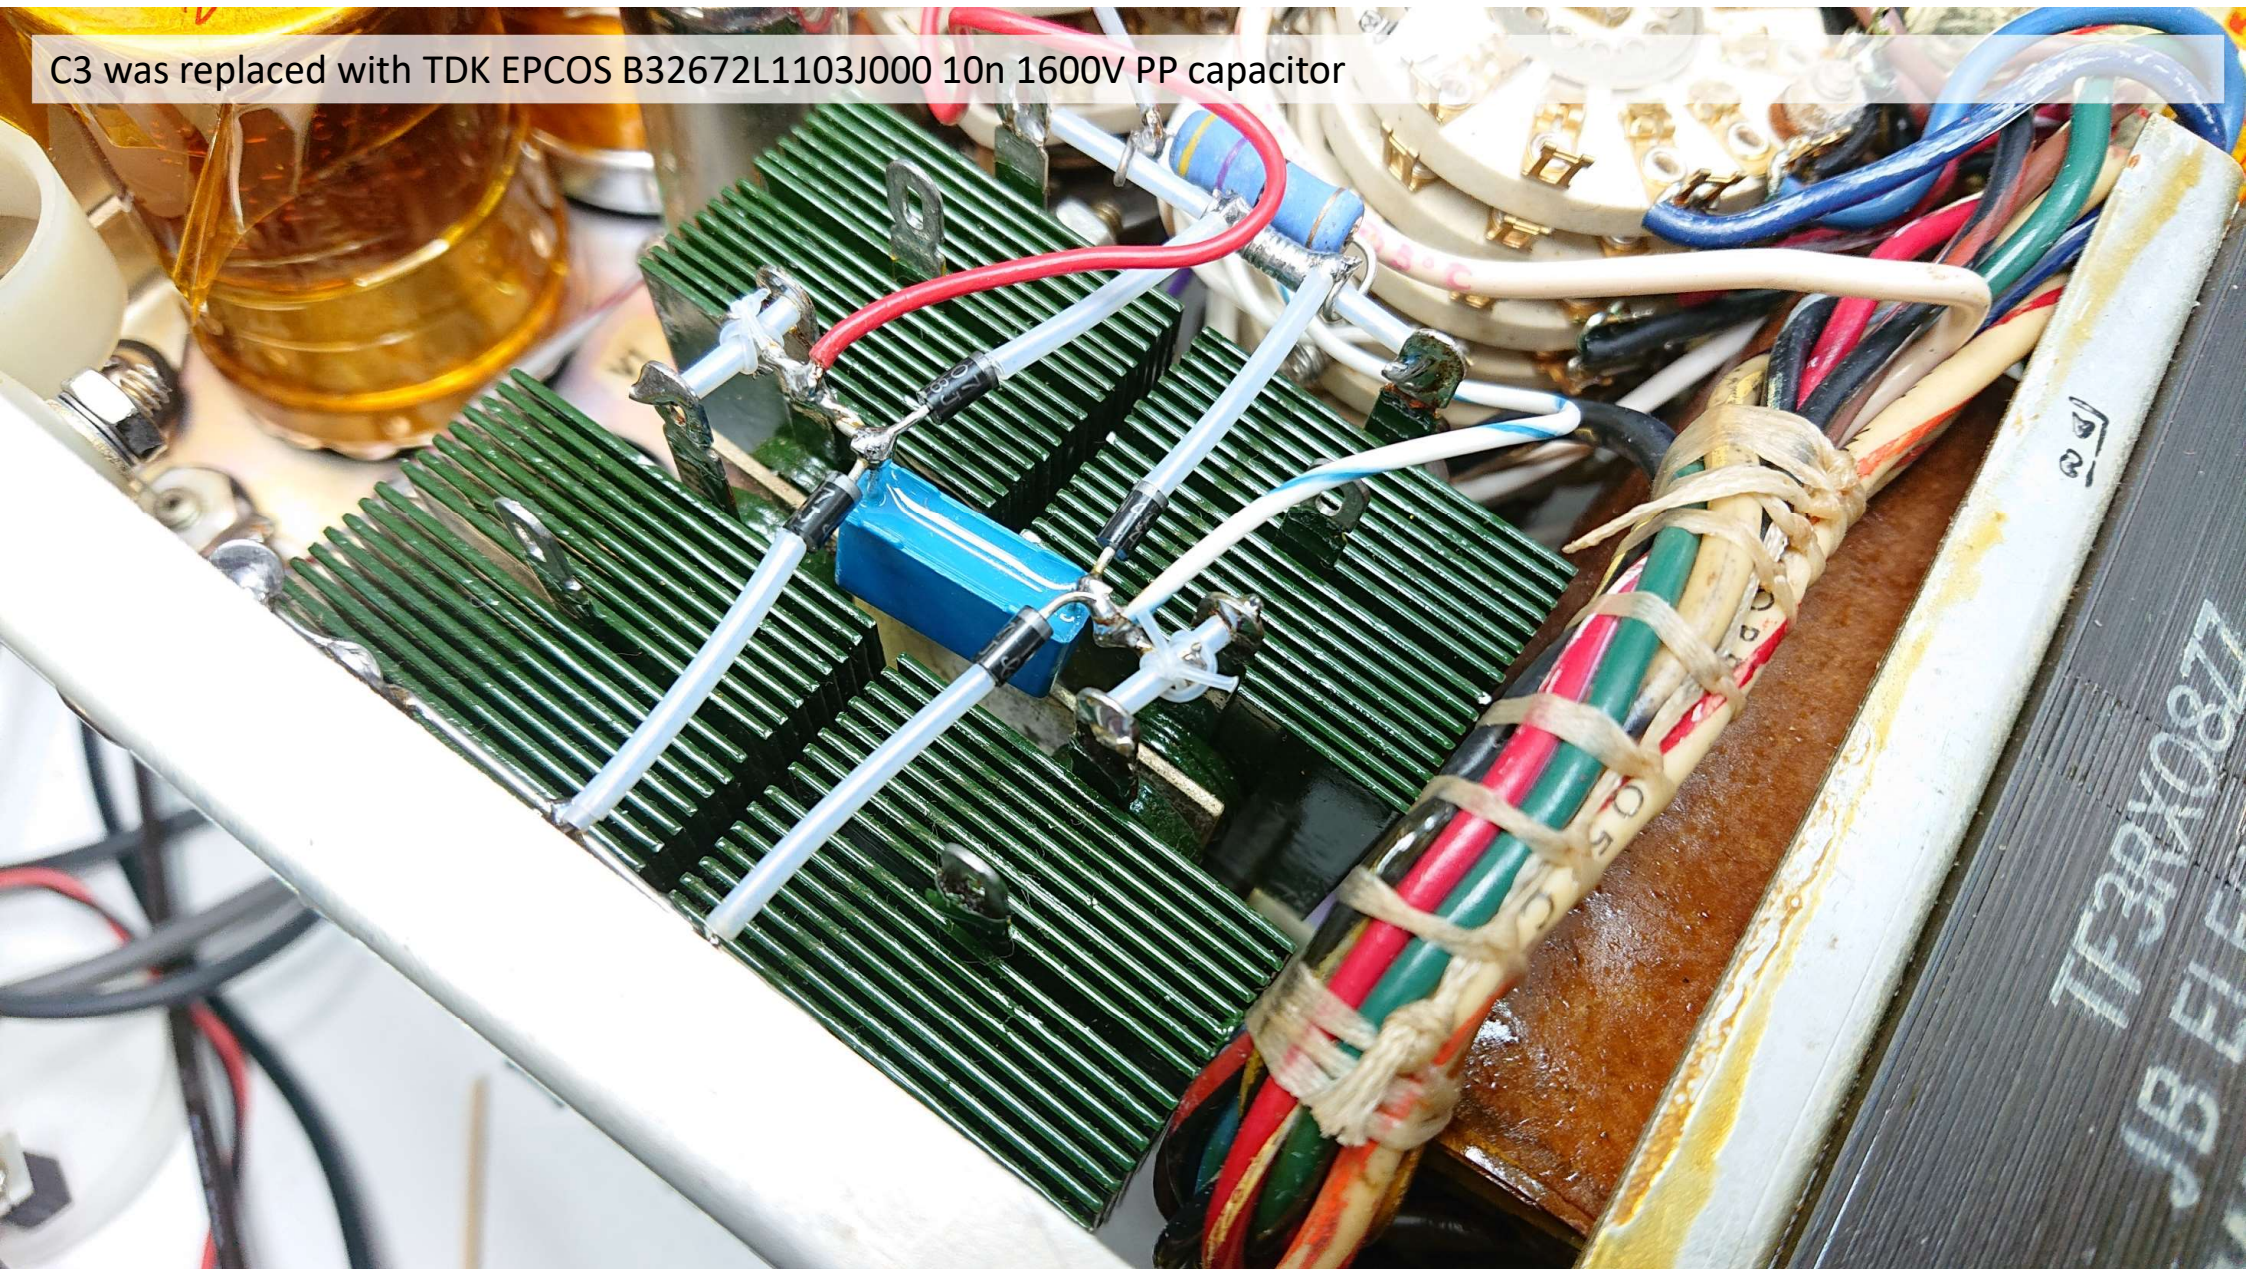
Fuse holder replaced with Littlefuse 03420006Z waterproof type 15mm hole size, original holder overheated causing fuse to blow under prolonged operation
